Elpas2 Product Advisory – RF Ethernet Reader

Nov 19th, 2009 – A limited quantity of Elpas2 RF Ethernet Readers (P/N:5-RFB00433) have been shipped to partners with a firmware functionality issue that under certain conditions may affect the reader's ability to reliably detect tag messages at read ranges of less than 5ft/1.5meters.

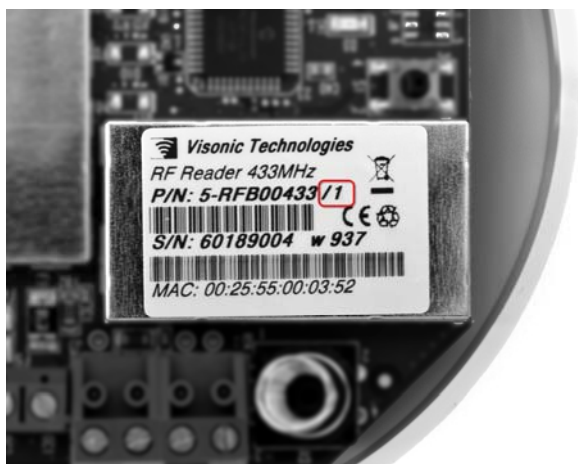
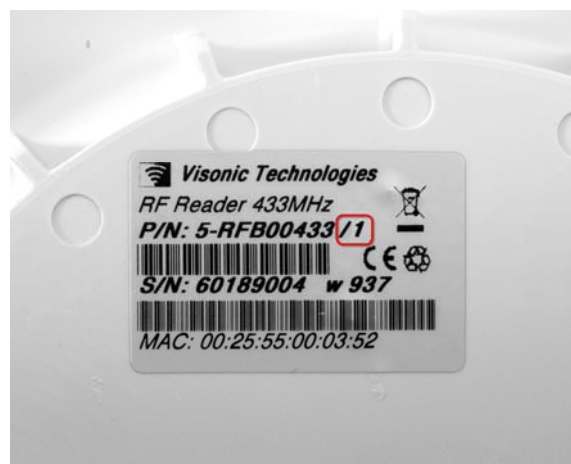
The issue affects only those RF readers manufactured prior to November 1st, 2009 and are easily identified by the Rev 1 designation on the product labels affixed to the reader.

To resolve this technical issue, partners should immediately upgrade the reader firmware at all relevant Elpas2 installations (See page two of this advisory for details).

All subsequent Elpas2 RF Ethernet Readers identified by the Rev 2 designation on the reader's product labels (manufactured after Nov 1st, 09) do not require this firmware upgrade
