H3688TB
12/19/2016

Tech Bulletin

SUBJECT: MISLABELED L-NET TERMINATION BOARD - 350003

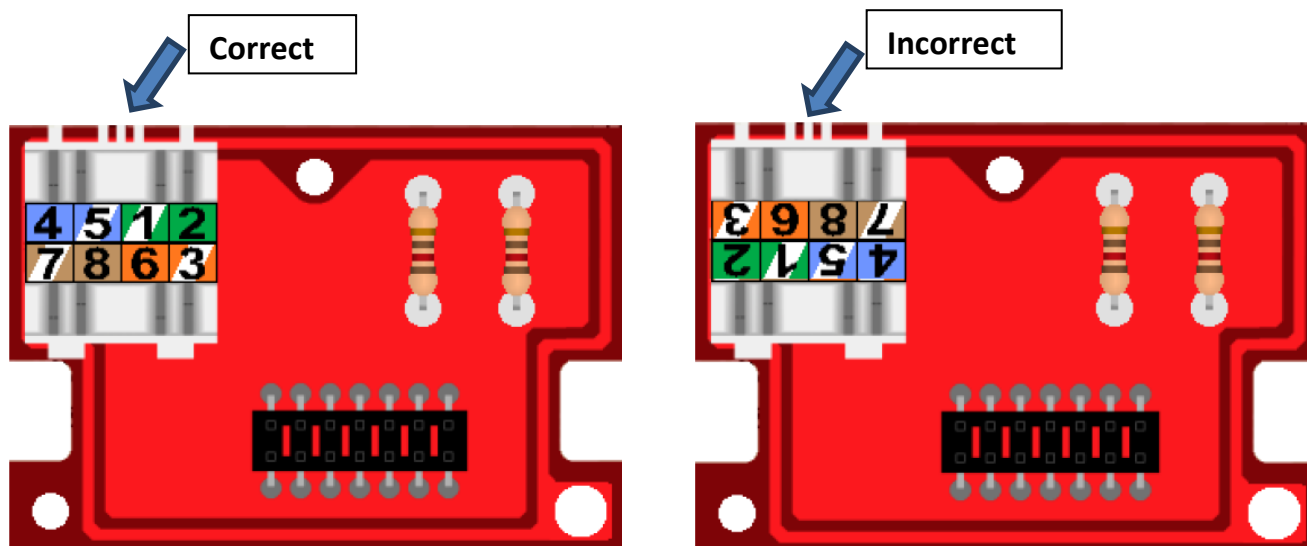
Problem Identified: Rauland has discovered that some L-Net Termination Boards 350003 may exhibit an upside-down wiring label. See illustration below:

When an L-Net Termination T-Tap is wired onto an L-Net cable via a transposed color code label, the signals in the 'green' pair will be shorted together and the signals in the 'orange' pair will be shorted together. This will immediately disrupt communication for all devices that share the affected L-Net cable. This fault would be noticed immediately upon application of power to the devices connected to the L-Net cable.

If an upside-down label leads to transposed wiring, the data circuitry is fault-protected for both positive and negative voltage power supply wiring errors. A Corridor Light or Domeless Controller's power supply circuitry cannot be damaged by the current-limited data signals.

Please reference KI-2234N '*Responder 5 System Design Guide*' and KI-2236L '*Responder 5 Accessories Installation Guide*' for proper installation guidance.

If you have received a mislabeled L-Net Termination Board, do not install it. Please contact Healthcare Technical Support to arrange for a replacement.
