# TECHNICAL NOTE 27

## FIBROSCAN 530 TOUCHSENSOR

### ADJUSTMENT

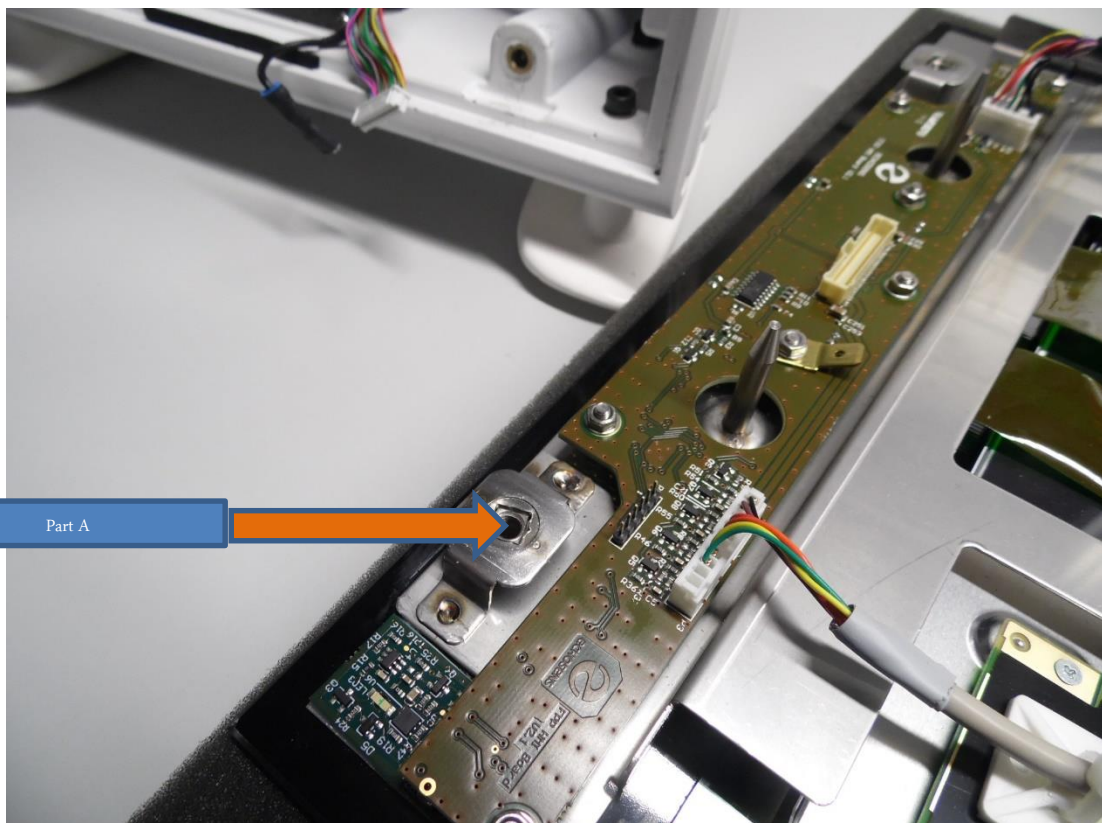
IMAGE 1

It can be noticed on FibroScan 530 manufactured before June 2016 (F80081) that part A supposed to attach LCD coverglass M300001 to the frame is not deep enough( image 1) .

In order to avoid the upper mentioned phenomenon in case of repair or preventive maintenance one should have the 3 following actions:

- I. Add a 1mm large EPDM (429mm length) joint on the vertical (blue lines of Image 3)

- II. Add an M5 1mm washer on top of the frame threading (see Image 5) with glue (cyanoacrylate)

- III. Unscrew both cleats (see Image 7) and pull them toward the operator as much as possible then refasten 4 screws afterward.

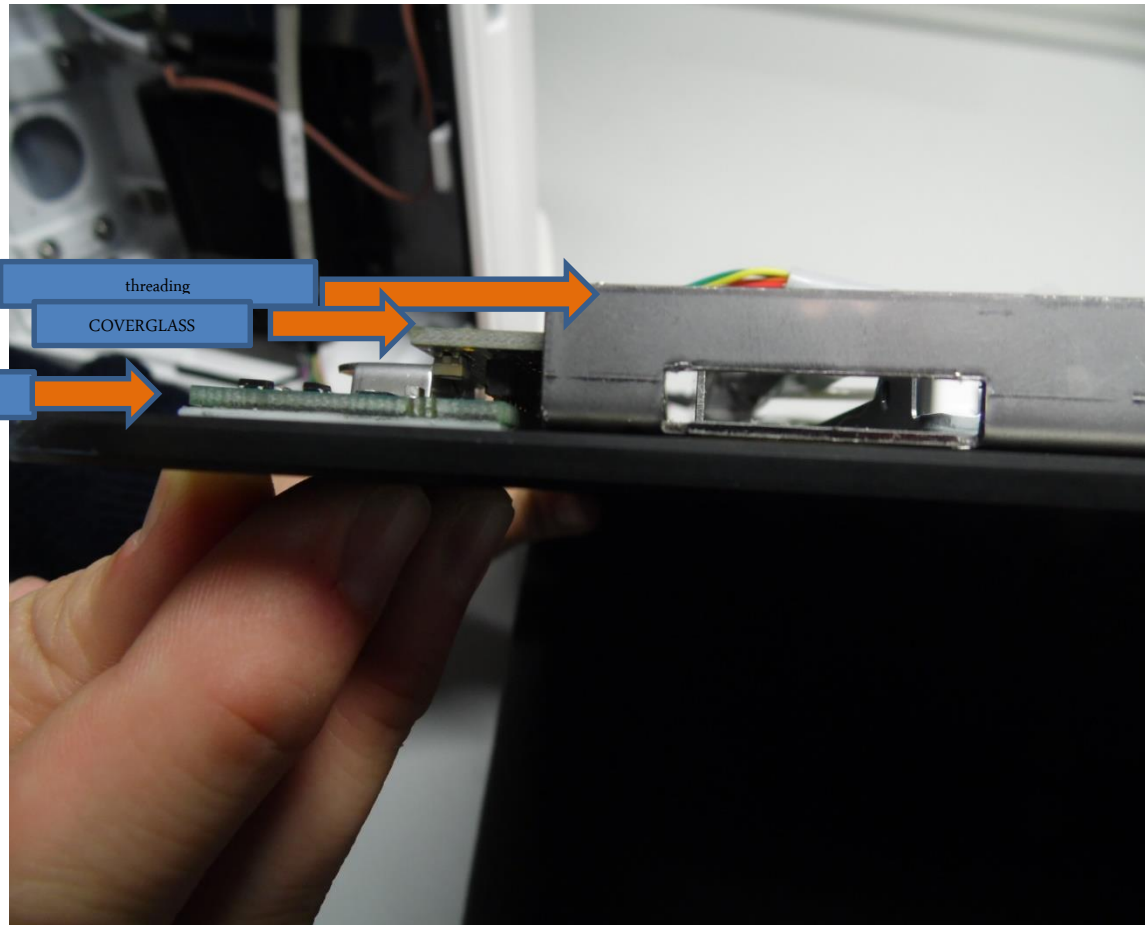
IMAGE 2

As a consequence the outer cover screw (see E320M003\_2\_TechnicalmanualFibroScan530.docx for assembly details) will pull the metallic frame of the CoverGlass away from the glass and the glue between the frame and the glass might fail; Of this fact, the contact between the HMI board and the Touchscreen PCB (both included in HMI M300017) will become uncertain (image 2) hence the device not turning on/off or turning on/off on its own.
