TECHNICAL NOTE 11

402 FRONT COVER LEXAN

Written by Yacine IDIR

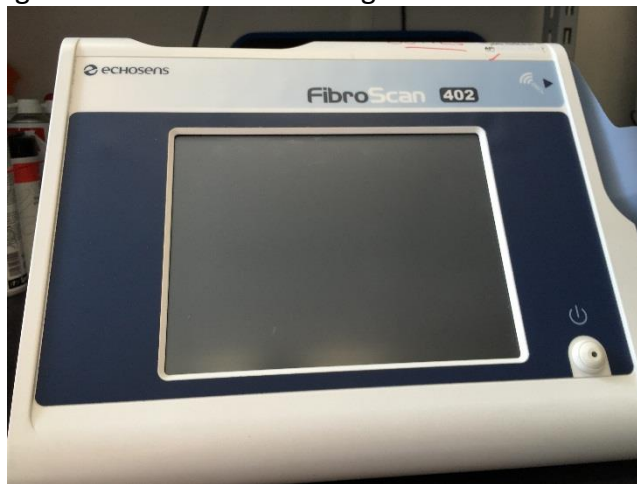
Each FibroScan 402 having a front cover lexan damaged.

- a. After each reception of a 402 unit at our workshop or during an intervention or preventive maintenance on site, check the condition of the front cover lexan.
- b. If the front cover is well applied and undamaged, there is nothing to do.
- c. If the front cover lexan is damaged then proceed as following.

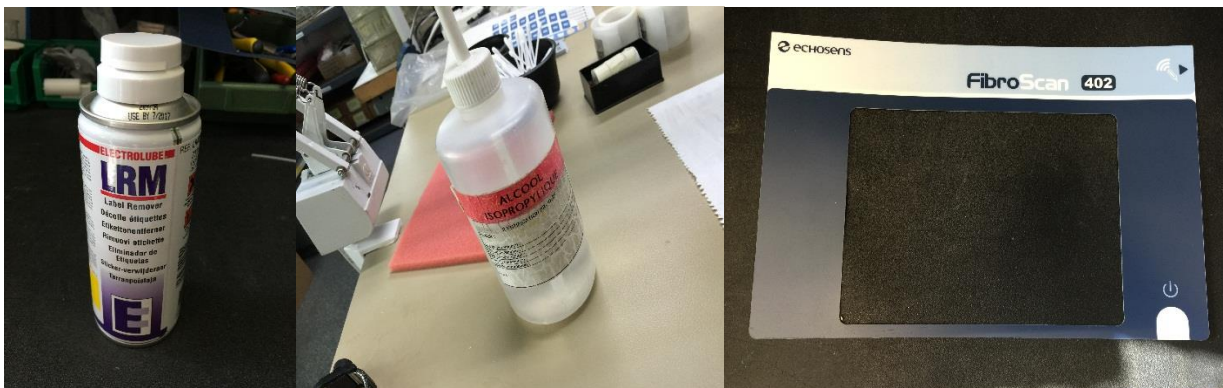
- a. Label remover
- b. Isopropyl alcohol
- c. A new front cover lexan

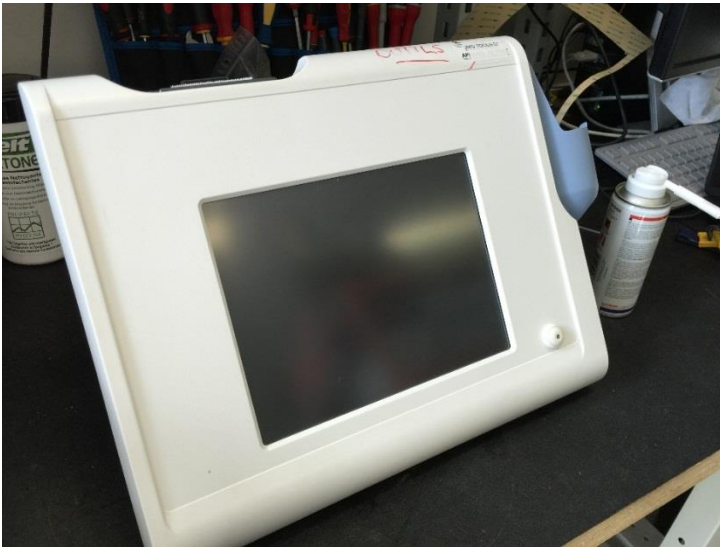
- a. Remove the damaged front cover lexan using the Label remover.

- b. Apply some Isopropyl alcohol all around the surface in order to remove any adhesive residue.
- c. Wait 15min for having a totally dried surface.

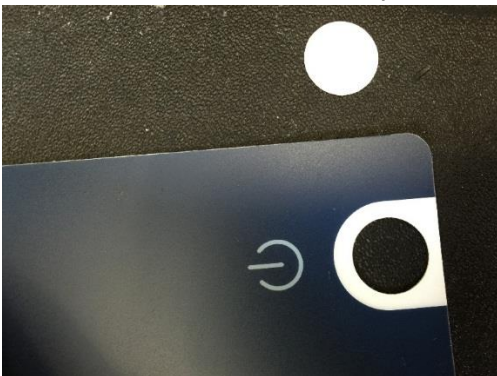
0. Pull-out the button's protective cap on the new front cover lexan.

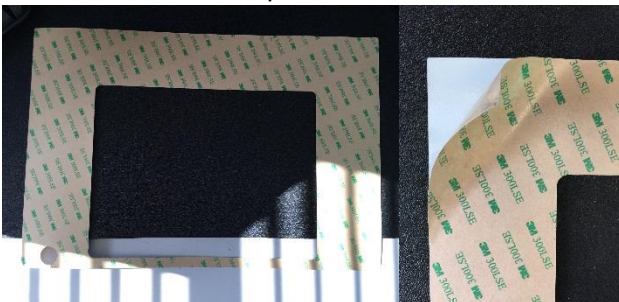
1. Remove the protective film from the back of the new lexan.

2. Slowly apply the front cover lexan starting from the button's area until reaching the top. Then slowly apply the lexan from the right side to the left side.
3. Make sure no air is trapped between the front cover body and the front cover lexan.
